CHRYSLER LX Chassis Tire Wear and Suspension Maintenance

2005 ON CHRYSLER LX CHASSIS: CHRYSLER 300C, DODGE CHARGER, CHALLENGER AND MAGNUM

LX LX Rear Sub-Frame Failures

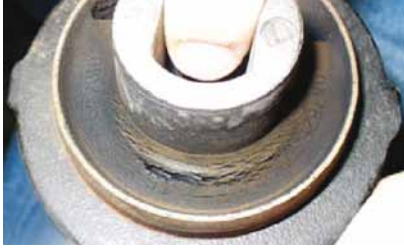
Well Worn LX Radius Rod Bush

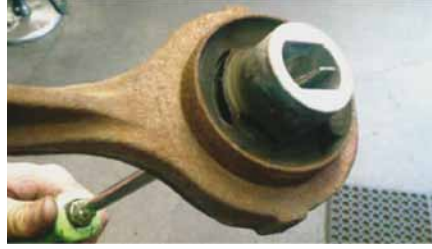
A Radius rod bush can be inspected with the vehicle on a lift and a flash or shop light. As rubber ages, ozone causes the surface of the rubber to oxidize. A reddish brown ring where the radius rod bush moves is completely normal and requires no maintenance. A radius rod bush with cracks, tears or worse should be immediately replaced. Not only does the excess motion of the radius rod arm caused by a bad bush contribute to tire wear, it creates steering that is sloppy and contributes to wandering and pulling under way or when stopping. Chrysler offers replacement only of the entire arm and bush assembly. Pedders EP6567 is a severe duty cycle bit that replaces only the bush making it very cost effective. The manager or technician will walk you into the shop so you can see the condition of the bush.

Severely Worn LX radius Rod Bush

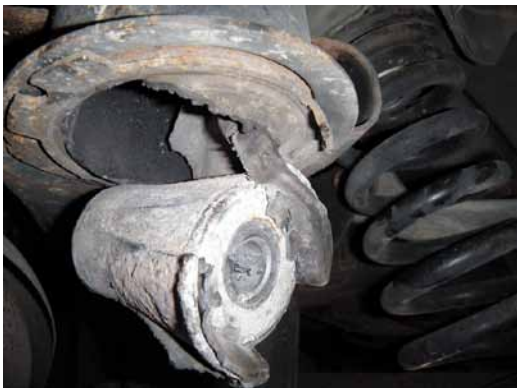
use a superior urethane material with much larger control surfaces to better carry the load, while maintaining close to OE cabin noise levels through the use of void technology. The OE bush is dependent on an aluminium to rubber bond to hold the ferule in place. The pictures graphically illustrate how dramatically corrosion destroys this bond leading to failure. The Pedders LX sub-frame bush is trapped with a metal plate and does NOT use a bonded ferule, completely eliminating this from of failure.

This is caused by road salt corroding the aluminium ferule. This is a complete total falling out of the car failure

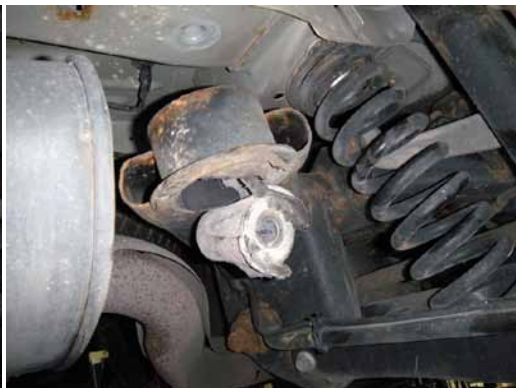
Same salt corrosion failure, different view.

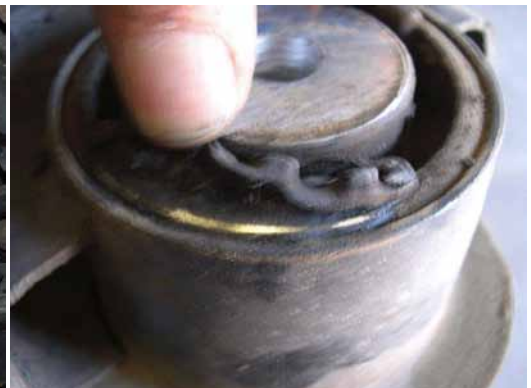
The second cause of failure is tearing. The pencil size OE rubber ridges are replaced with Pedders large flat thick urethane discs. By design, Pedders LX sub-frame bushes completely eliminate tearing of control surfaces in the LX sub-frame bush.

The control surface of the bush is torn from normal wear.

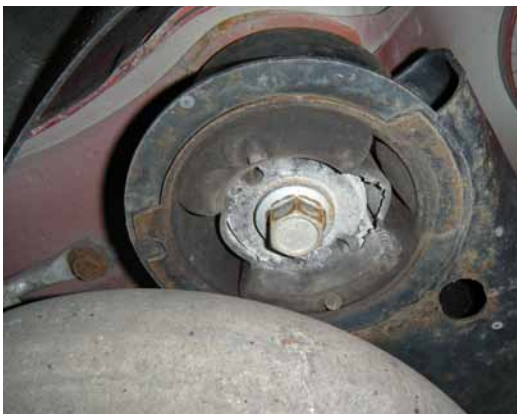
If you see white oxidation on your LX sub-frame bush, it requires replacement.

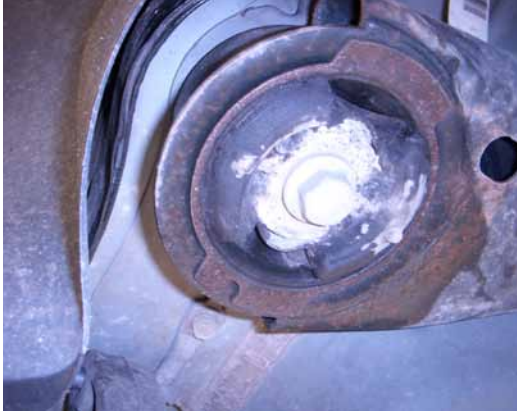
This is a salt caused failure on a Dodge Charger used by an Indiana Sherriff's Department.

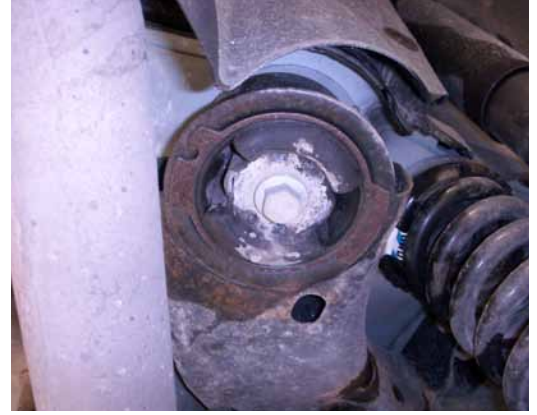
Cass County Sheriff Second Failed Bush by Corrosion

The Cass County Sherriff's Department sought out Pedders when their Dodge Charger dropped out of an emergency call. The driver was going through a high speed corner when the vehicle shifted. He thought it was a blow out. The tires were fine. The condition persisted. No one seemed to be able to identify the problem. The dramatic shift that felt like a flat tire was being caused by two severely corroded sub-frame bushes allowing the IRS to shift so much under extreme driving conditions that the veteran member of the Sherriff's department felt the vehicle should be removed from service.

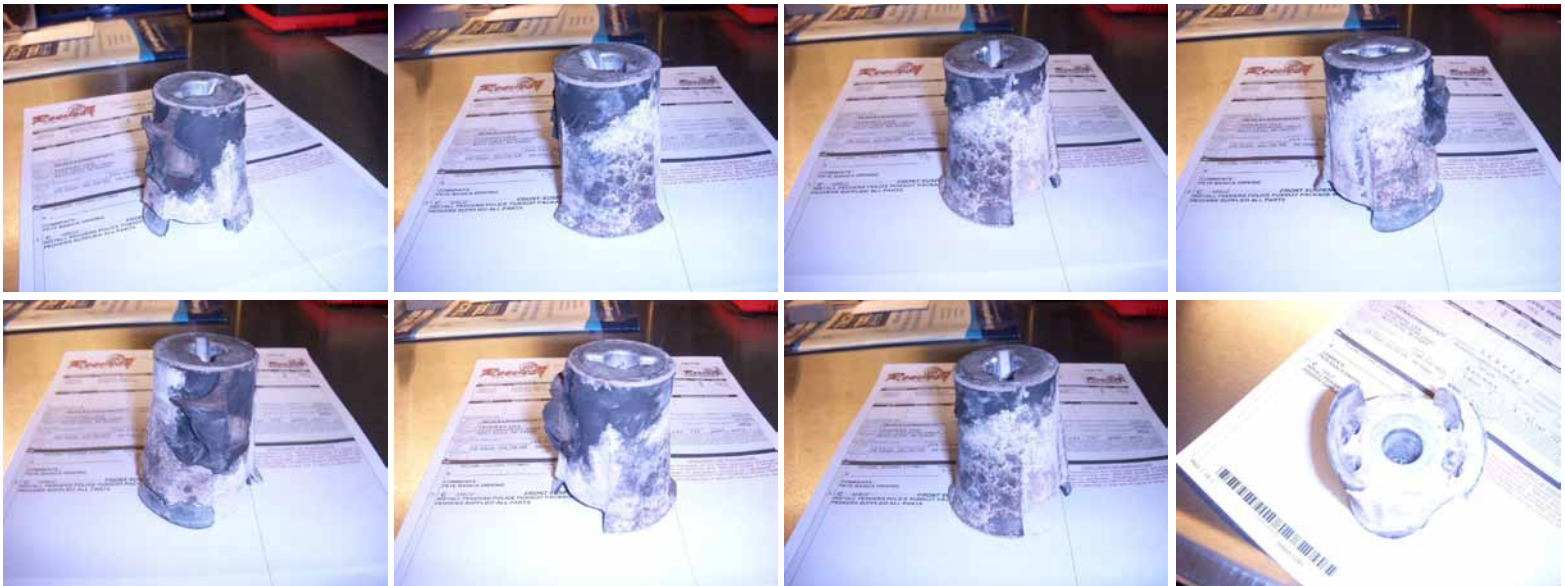
These are the failed OE sub-frame bush ferules removed from the Cass County Charger, the same ferules shown in the pictures on the vehicle on this same page. They don't look all that bad bolted in. Once the bush is removed from the vehicle we were able to pull the ferules out by hand. A new OE bush and ferule would require thousands of pounds of pressure in hydraulic press to be ripped out of the bush and the rubber bond would NOT have failed. The rubber near the bond would have ripped from the outer rubber of the bush. We took these out with our bare hands. The little bit of rubber that was still bonded to the ferule was hanging on by small shreds of rubber. The failed ferules allowed so much sub-frame movement that the car felt like it had a flat rear tire in turns and was not fit for service. Installing Pedders EP1172 complete eliminates the corrosion issue while dramatically increasing stability over a brand new OE set of rubber bushes.
